# Report on the 2014 Interior Renovations to the Mandela Park WaSH-UP Facility

Abstract: This report documents the renovations made to the Mandela Park WaSH-UP Facility in Langrug in 2014 and makes recommendations for future improvements. The document is designed to help future projects in the facility by sharing the physical changes made, explaining the purpose behind these renovations, and providing recommendations for future renovations to the facility. Furthermore, the information collected here can be utilized by others creating or renovating WaSH-UP facilities.

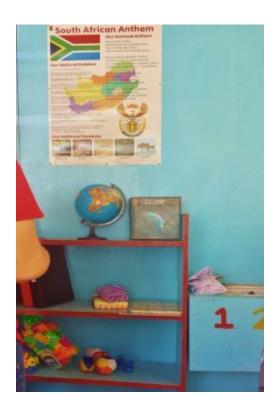
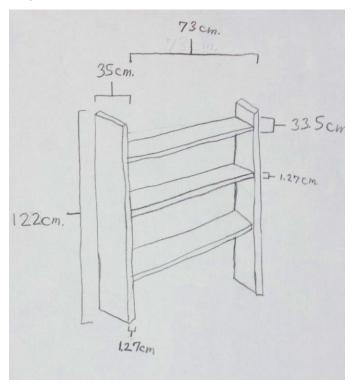
The shelves are made in the form of a freestanding bookcase, located to the left of the sinks. The shelves were constructed of wood, found in the storage bungalow of the facility. The bookcase is approximately 122 cm tall, 73 cm wide, and 35 cm deep. There are three shelves and also enough space beneath the bottom shelf to place two plastic milk crates. Each shelf is held to the supporting sides with three screws on each side, spaced approximately equally apart. Before construction the shelves were painted blue with oil-based paint. After construction the outside edge of the shelves was painted red.

The bookshelf currently is slightly crooked due to a combination of uneven flooring, nonparallel walls to work with, and slightly uneven pieces of recycled wood. Future projects should consider the slant of the wall that the bookshelf will lean against and the uneven floor to ensure the bookshelf has maximum stability. Additionally, the bookshelf is not very large, so future projects can create more shelves for storing a growing library and separate the aftercare toys into another area.

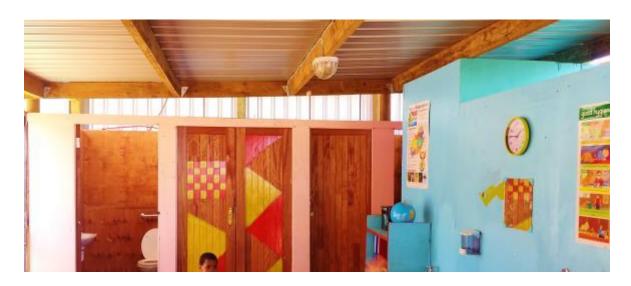
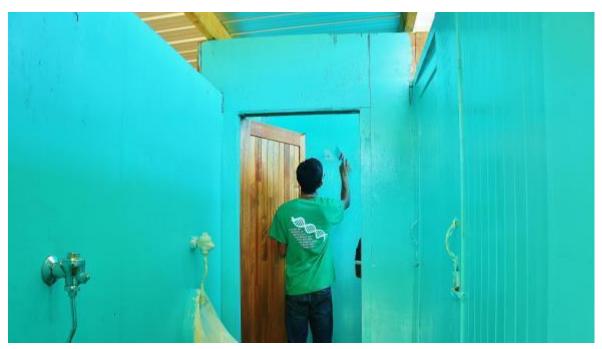
The men's area of the bathroom, including the shower area, urinal wall, doors to the toilet stalls, and adjacent privacy wall were painted with 5L of white oil paint mixed with 7 bottles of green dye. The women's area including the shower and the spaces between the doors of the toilet stalls was painted peach with 5L of white oil paint mixed with 3 bottles of red dye and 2 bottles of yellow dye. The wall surrounding the sinks, and the sink area were painted blue with 5L of white oil paint mixed with 3 bottles of blue dye. The doors to the children's stalls were decorated with red and yellow designs both from 500 mL cans of paint. All paint items were purchased at the Build-It in Franschhoek.

Although very difficult to clean, the oil paint was useful because the wood had been previously varnished and also the paint needs to stand up to exposure from weather and constant wear. To help clean the oil paint spilled on the floor, use turpentine and wire brush to remove paint stains.

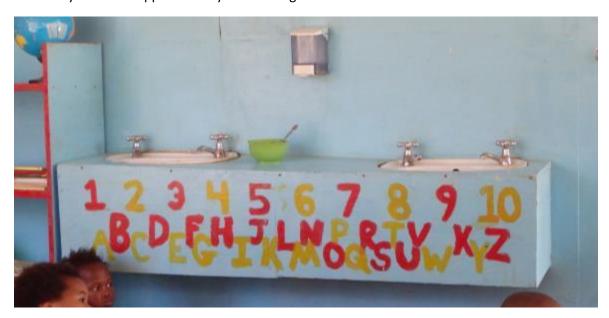
The alphabet and numbers 1-10 were painted with red and yellow paint, leftover from painting the children's doors. The letters and numbers were hand-drawn in pencil and then painted over and the symbols are approximately 4 inches high.

The alphabet and numbers intrigue children who visit the facility and can be used as a teaching tool. We would encourage future projects to work on developing more formal educational activities utilizing such information.

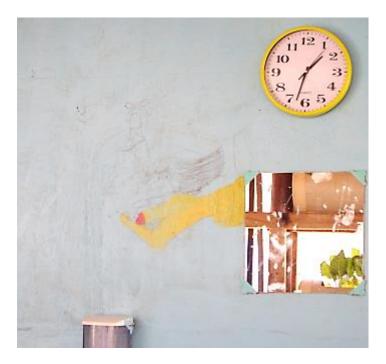
The image is of two hands being washed sketched in pencil centered above the sinks. It is approximately 1.5'x1.5'. One hand is painted in yellow oil-paint, with plans to paint more, which was not completed before leaving.

This renovation was left incomplete, so ensuring the image is finished with oil paint over the pencil drawing and also adding the words would be highly recommended.

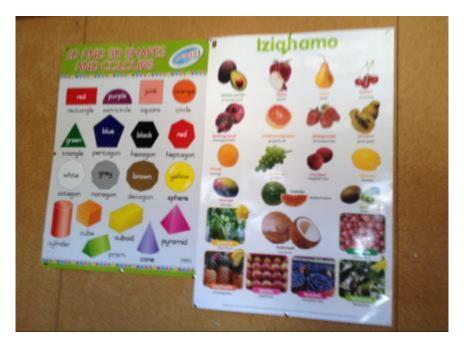
Four posters were purchased from Osmond's. Two were hung in the facility, one to the left of the sinks above the library bookshelf, one to the right of the sink (figures 1 and 2). Two were hung in the storage bungalow (see figure 3). All posters were hung using tacks on each of the corners. Additional tacks were placed on the sides for increased stability. All tacks needed to be hammered into the walls due to the hardness of the walls behind the posters.

Figure 3: A posters on colors and shapes and a poster on fruit hung in the storage bungalow

There is room for more posters in the storage bungalow to help make the space more appealing and welcoming to children. Additionally, the posters provided many educational opportunities so encouraging educational programmes centered around the different posters would enhance their purpose.
