Improving Water Quality of Green Hill Park Ponds and Investigating the Feasibility of an Irrigation System Using Pond Water

An Interactive Qualifying Project submitted to
the Faculty of WORCESTER POLYTECHNIC INSTITUTE
in partial fulfillment of the requirements for the
degree of Bachelor of Science

23 June 2022

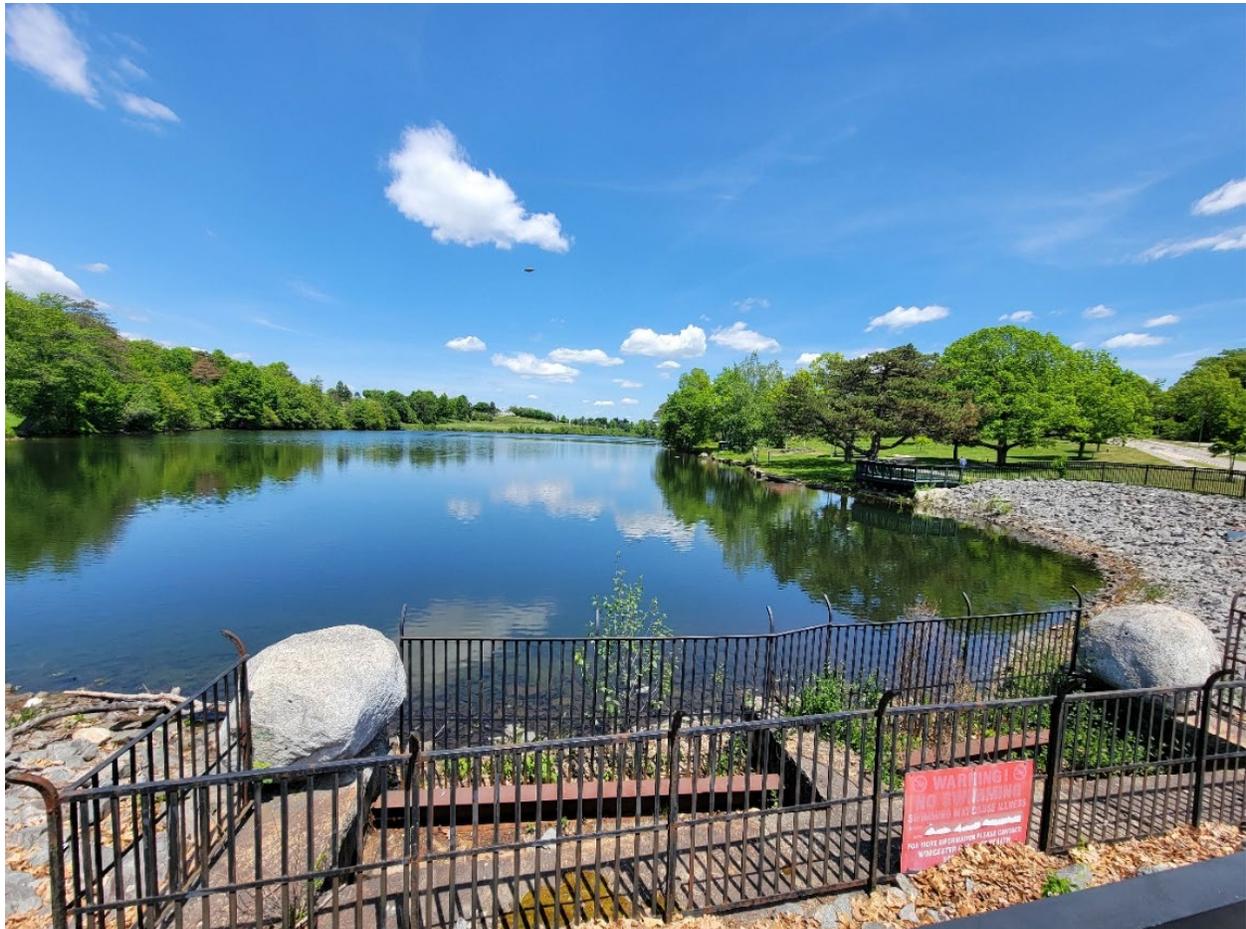
Figure 8: Image of Dam at Green Hill Pond

Brook valley and formed an extensive water body. It is a thirty-acre Pond surrounded by a Golf course and a Park, which is used by the community for various outdoor activities. The Pond has two outlets and drains into Lake Quinsigamond.

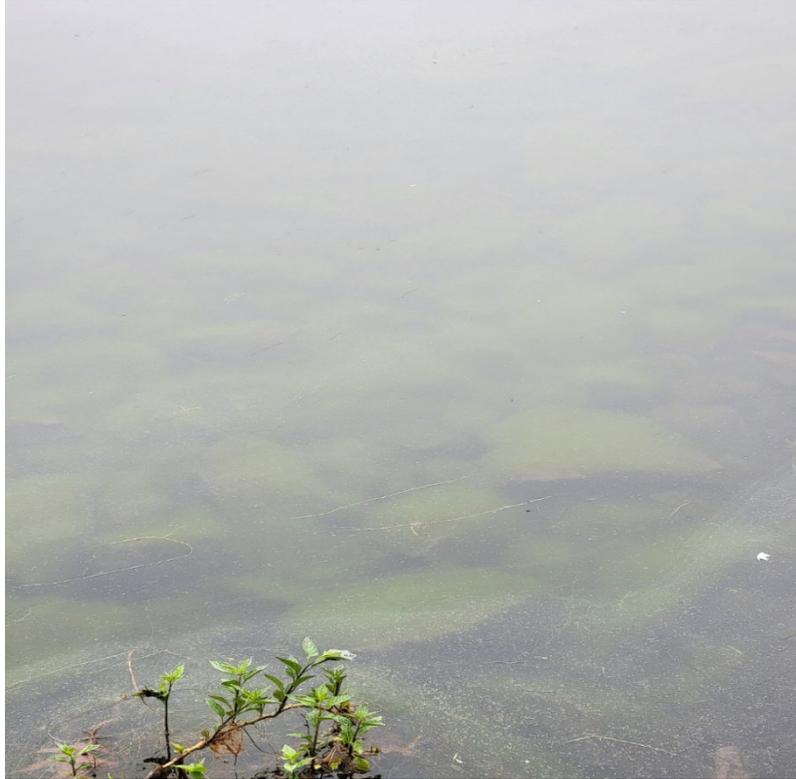
Figure 9: Image of early Algae bloom in Green Hill Pond

The Green Hill Park Coalition noticed the Ponds' water quality degrades in the summer months, citing significant algae bloom, causing the Pond to turn green in the summer months. The Green Hill Park Coalition participates in the City of Worcester Cyanobacteria Monitoring Collaborative to monitor the changes in the Pond's water quality. The Coalition has also been doing independent water testing for the past three years to further understand the changes in water quality.

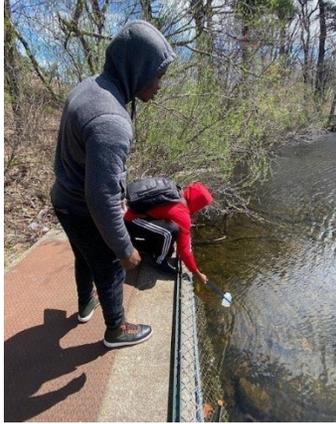
Figure 10: Baseline Water Test

For us to understand what was affecting the Ponds, we had to determine the baseline water quality. Before our research began, we collected water samples from both Ponds with assistance from our sponsor. The water samples were analyzed by Nashoba Analytical, a lab who analyzed previous water samples for the Green Hill Park Coalition (GHPC). This first water test was conducted before the water usually deteriorates, so we knew the qualities of the Ponds

before the summer. While Nashoba Analytical primarily tests for drinking water, we were able to use the Worcester Blue Space and the EPA guidelines for recreational water quality to create standards for our end goal.

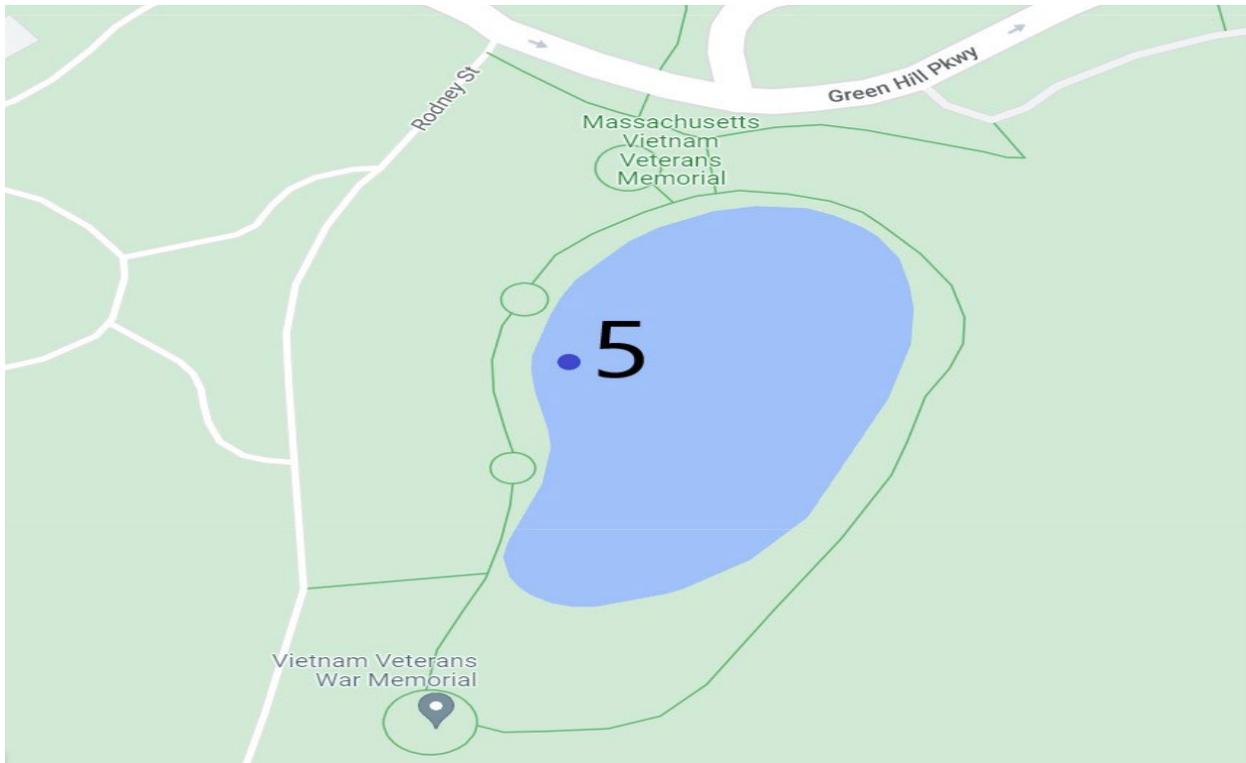
Figure 16: water sample location from the small Pond

In addition to the water test done at Nashoba Analytical, water samples were taken from the Green Hill Ponds to be analyzed at the Civil and Environmental Engineering laboratory at Worcester Polytechnic Institute (WPI). We went out to the park to collect five samples (Figures 13 and 14).

The water samples taken from locations 1, 3, and 5 were tested for Dissolved Oxygen (DO). The levels shown in table 2.

In addition to the dissolved oxygen test, we also tested water samples from all locations shown in figures 15 & 16 for total phosphorus concentrations. Phosphorus is a nutrient that is essential for plant growth. It is crucial to test the Pond water periodically to monitor the phosphorus concentration in the Pond water because phosphorus in the water can be used by aquatic plants and algae, which can lead to eutrophication. The current water test results show that the Phosphorus concentration in the Ponds is low. It is recommended that Phosphorus concentration in the Pond is as low as 0.01 ppm (Swistock, 2022).

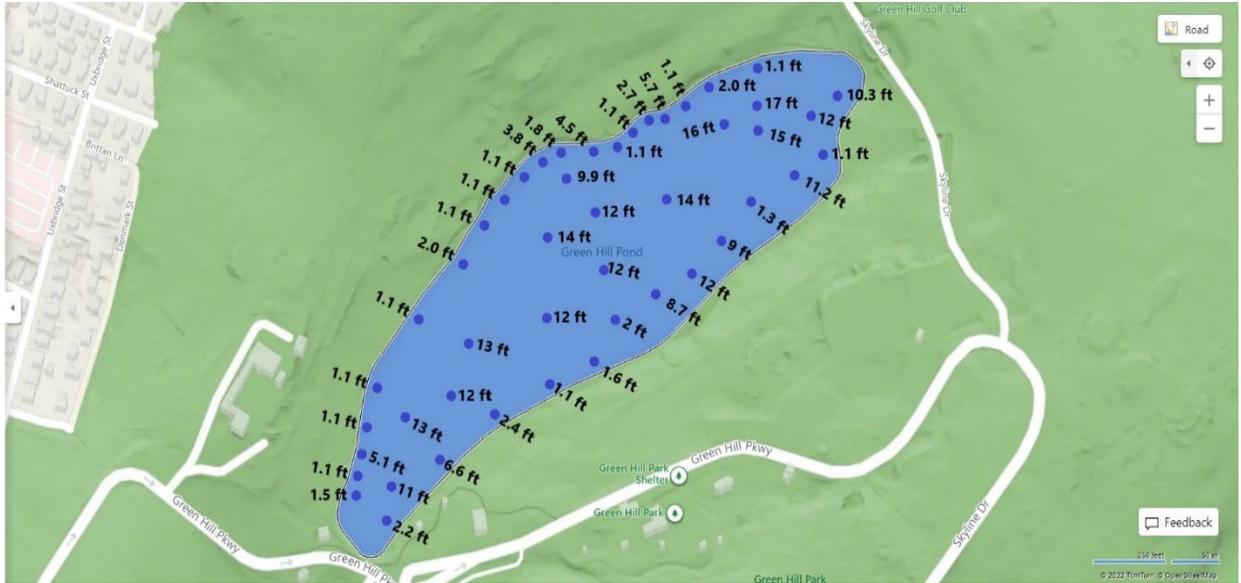
Figure 19: Green Hill Pond Mapped Depth

The second task to find the volume was to find the depth. We used a canoe and a depth finder to calculate the average depth of the Pond. We started on the southwest end of the Pond and paddled around the shoreline. Then, we paddled in the middle of the Pond. While we paddled, we took measurements at certain points using a depth finder and tracked where we took them on a map. Using the map and the depth points, we calculated the average depth, which came out to be 7.32 feet. Once we had the area and average depth, we found the volume by multiplying the area and depth. We found the volume to be 219.54 acre-feet or 71,537,316.1 gallons.

Unfortunately, the average was skewed because we took significantly more measurements around the shore than we did in the middle, where the Pond is deeper. The depth finder was also very erratic, as it would adjust the depth at random. We knew some of these were incorrect because, for example, it would show two feet at the shoreline, and then jump to 10 feet. We adjusted by using the first measurement shown, as that was consistently more accurate. Because the average depth is likely deeper than calculated, the volume is also likely greater than calculated.

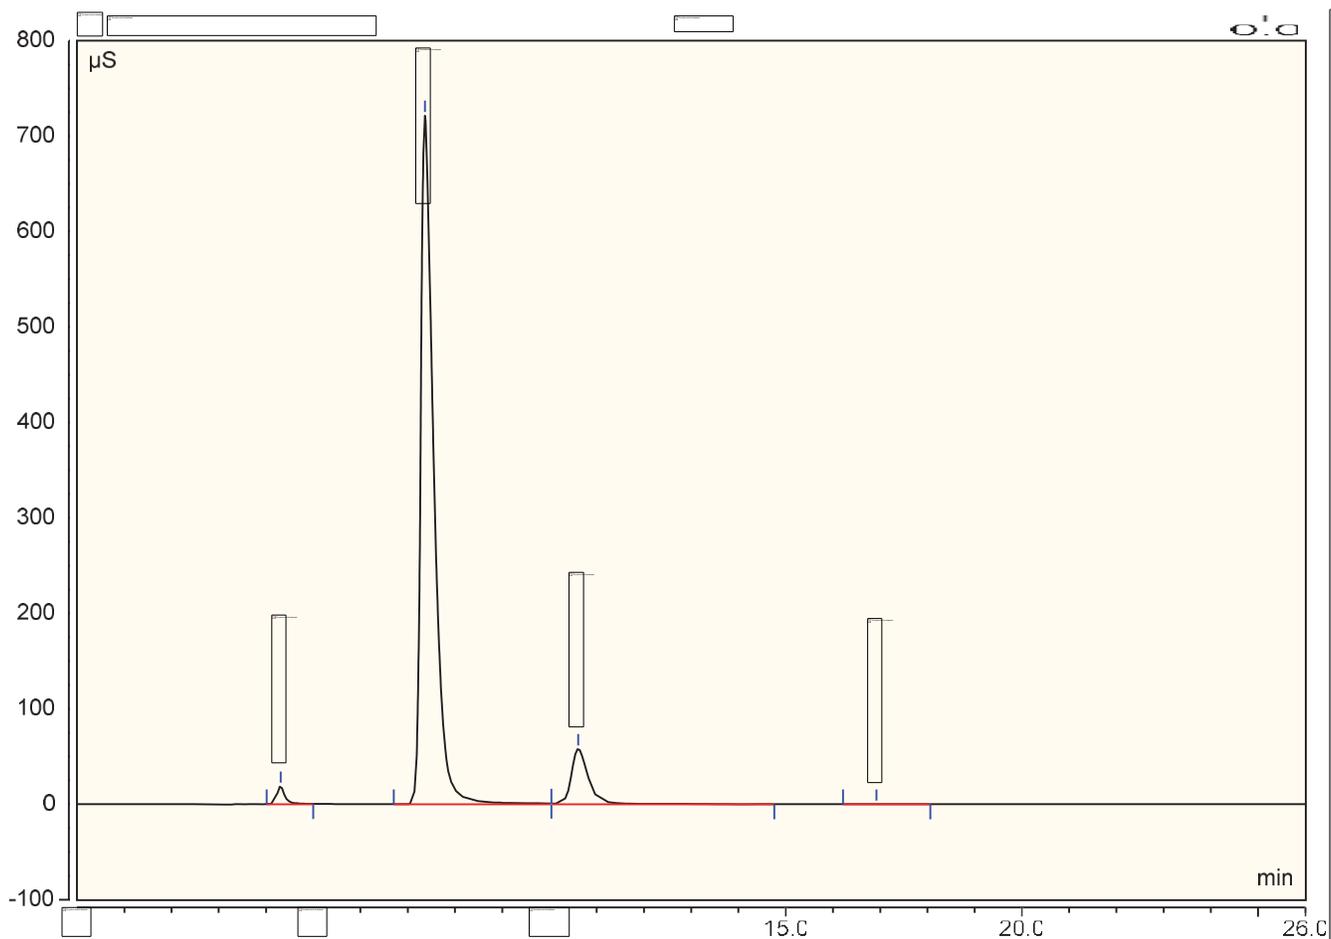
Sample Name:	GHP5	Inj. Vol.:	100.00
Injection Type:	Unknown	Dilution Factor:	1.0000
Instrument Method:	Anions_IM	Operator:	User1
Inj. Date / Time:	15-Jun-2022 / 19:22	Run Time:	26.00

No.	Time min	Peak Name	Peak Type	Area $\mu\text{S}\cdot\text{min}$	Height μS	Amount
1	4.31	Flouride	BMB	3.651	18.679	471.7121
2	7.36	Chloride	BM	230.649	721.312	45071.3865
3	10.61	Sulfate	MB	23.881	57.743	6247.6594
4	16.92	Bromide	BMB	0.041	0.065	19.2588
TOTAL:				258.22	797.80	51810.02
