Managing Flooding in Nantucket

IQP Project Report

December 2020

An Interactive Qualifying Project
submitted to the Faculty of
WORCESTER POLYTECHNIC INSTITUTE
in partial fulfilment of the requirements for the
degree of Bachelor of Science

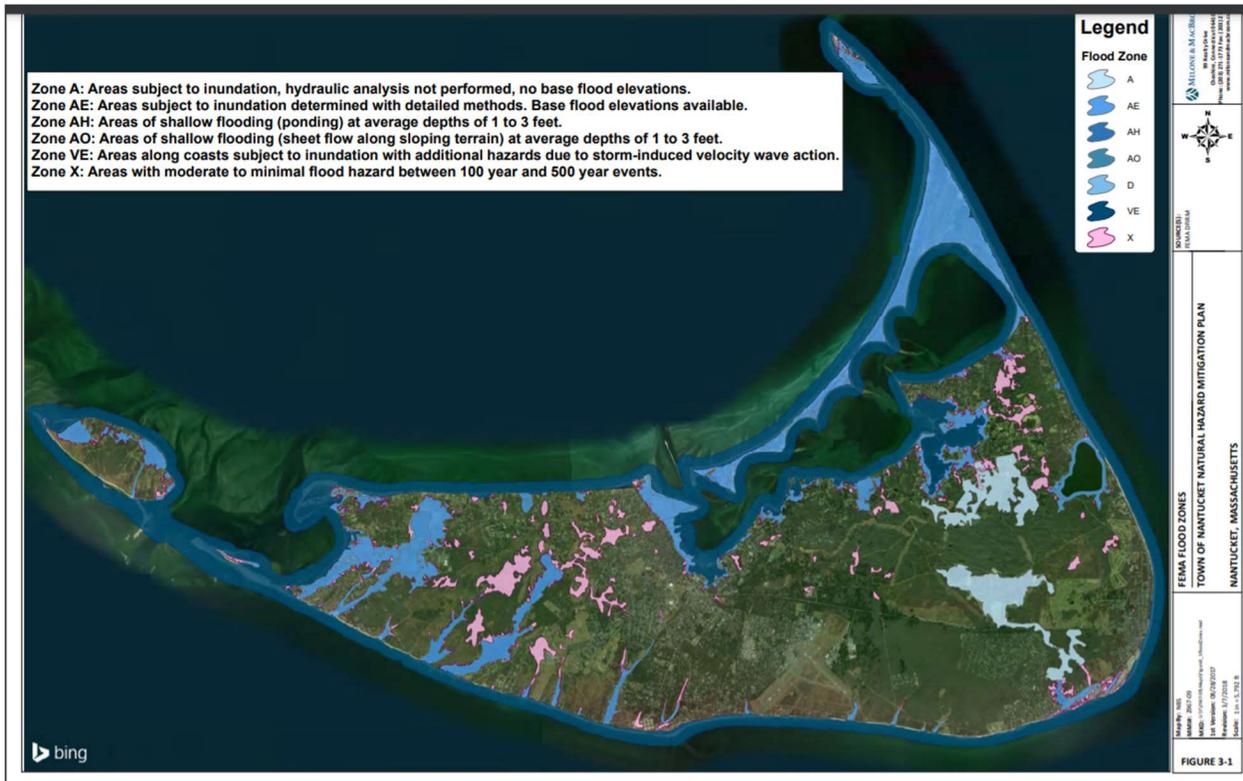
Figure 5: Map that shows predicted flooding areas for certain flood events, much of the downtown area according to this map is expected to flood (Hazard Mitigation Plan, 2019)

Many areas on Nantucket experience frequent flooding as highlighted in blue on Figure 5, especially the downtown area around the harbor. Specific areas subject to flooding in the downtown area include Easton Street, South Beach Street, Children’s Beach, Easy Street. (Figure 6). Other areas located downtown that also experience frequent flooding include Washington Street, Broad Street, Francis Street, and the White Elephant Hotel (Hazard Mitigation Plan, 2019). Tidal inundation and storm surges cause most of the flooding in these areas. Bulkheads

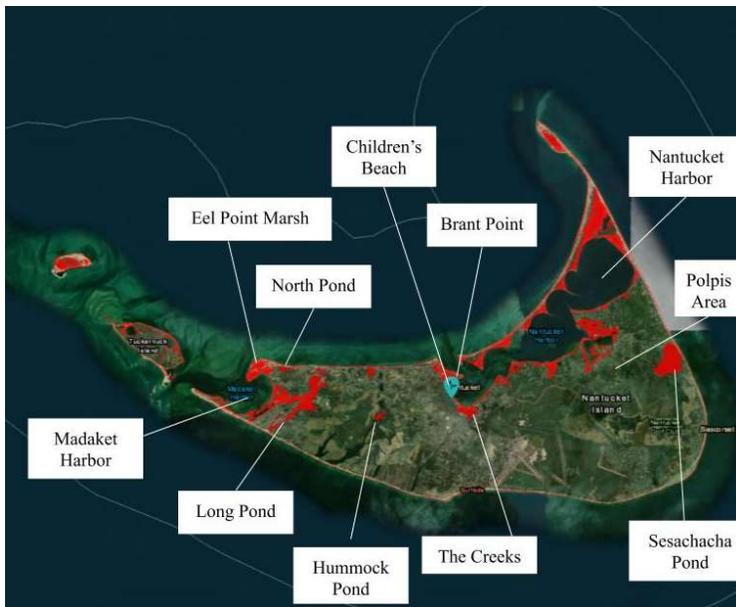
Figure 12: Areas prone to high tide flooding (NOAA’s Sea Level Rise viewing tool). Callouts added after retrieving the figure (October 13, 2020) (NOAA Logo Sea Level Rise Viewer).

While Figure 9 portrays a gradual increase in sea level rise, future projections by NOAA suggest increases may be exponential (Figure 11). As a result, Nantucket may see a much more rapid increase in sea level rise within the next few decades. Areas on Nantucket that may be most heavily impacted by such changes are (from west to east) Madaket Harbor, Eel Point Marsh, North Pond, Long Pond, Hummock Pond, Children’s Beach, Brant Point, The Creeks, Polpis area, Nantucket Harbor, and Sesachacha Pond (Figure 12).

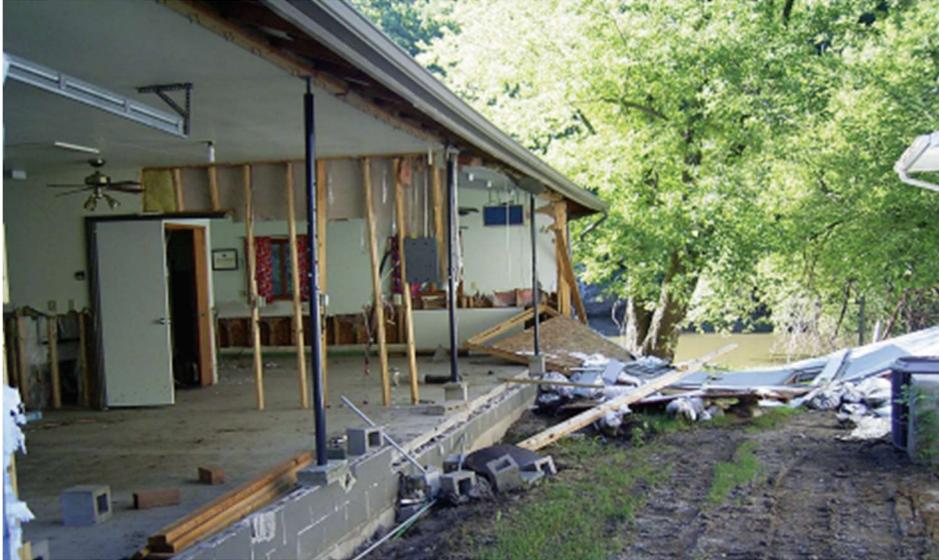
Figure 14: A home which had the wall ripped off due to flood water velocity (FEMA, p.31)

Water velocity is one of the most dangerous parts of a flood. Water weighs 63 pounds per cubic foot. Even slow-moving water can impart a significant force on anything in its path. To resist the water objects in its path must exert an equal and opposite force or be swept up and carried with the flood (Pistrika et Jonkman 2009, p.426). Water can move cars, mailboxes, and trees. If a person is caught in flowing water, they will be swept away if the flow is fast and deep enough. Water velocity adds to the force of hydrostatic pressure and the force generated by water flow compounds on the force applied from water weight causing structural failure. The flow imparts additional force on the building as water flows past. This force can damage home paneling or remove molding (Figure 14) (FEMA 2014, p.30).

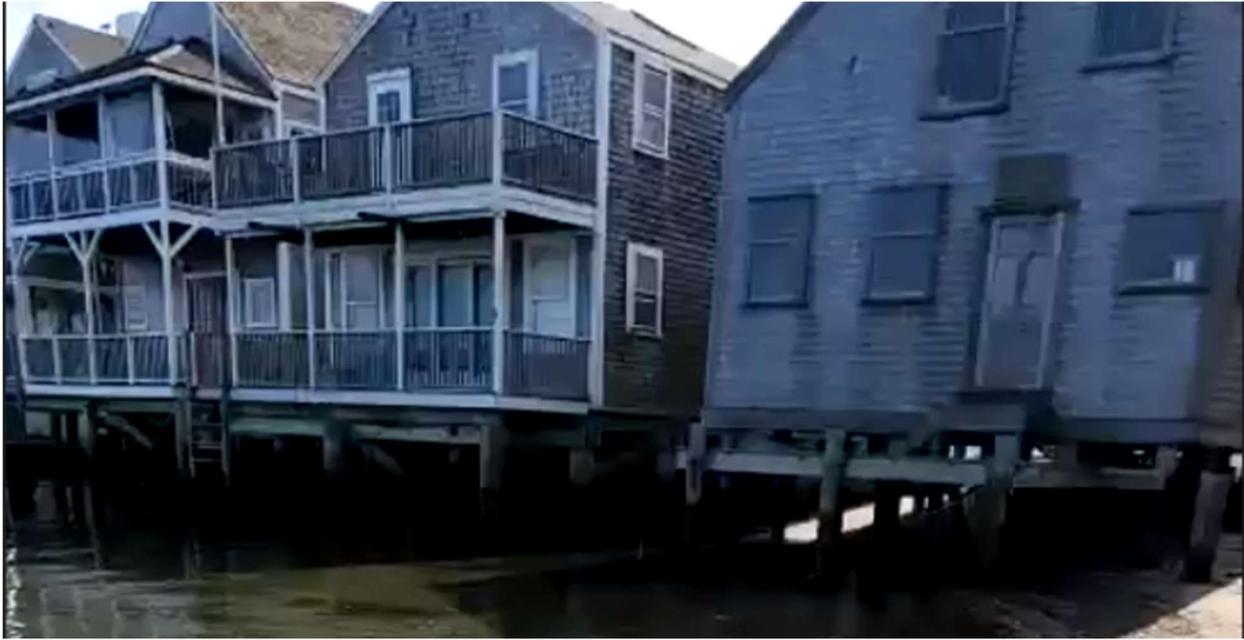
Figure 15: Houses on stilts in the North Wharf area (V. Murphy, personal communications, Sept. 25, 2020)

Elevation effectively reduces the risk of flooding by raising the structure in danger. Elevating the structure prevents flood waters from reaching the inhabited part of the building or the building's utilities. Elevation is done by using jacks to progressively lift the structure and build supports underneath. The goal of elevation is to allow the flood waters to pass under the house or around a raised foundation, preventing water from entering the home. Elevating a building is theoretically simple for many timber-framed buildings on Nantucket although it may be expensive (FEMA 2014, p.104). Many houses around the harbor are built on pilings (Figure 15) and elevated on stilts (Figure 16), and many houses in flood prone areas have already been elevated on stilts or floodproof foundations. Elevation presents a viable solution to flooding without extreme change to the layout or location of the buildings on the island.

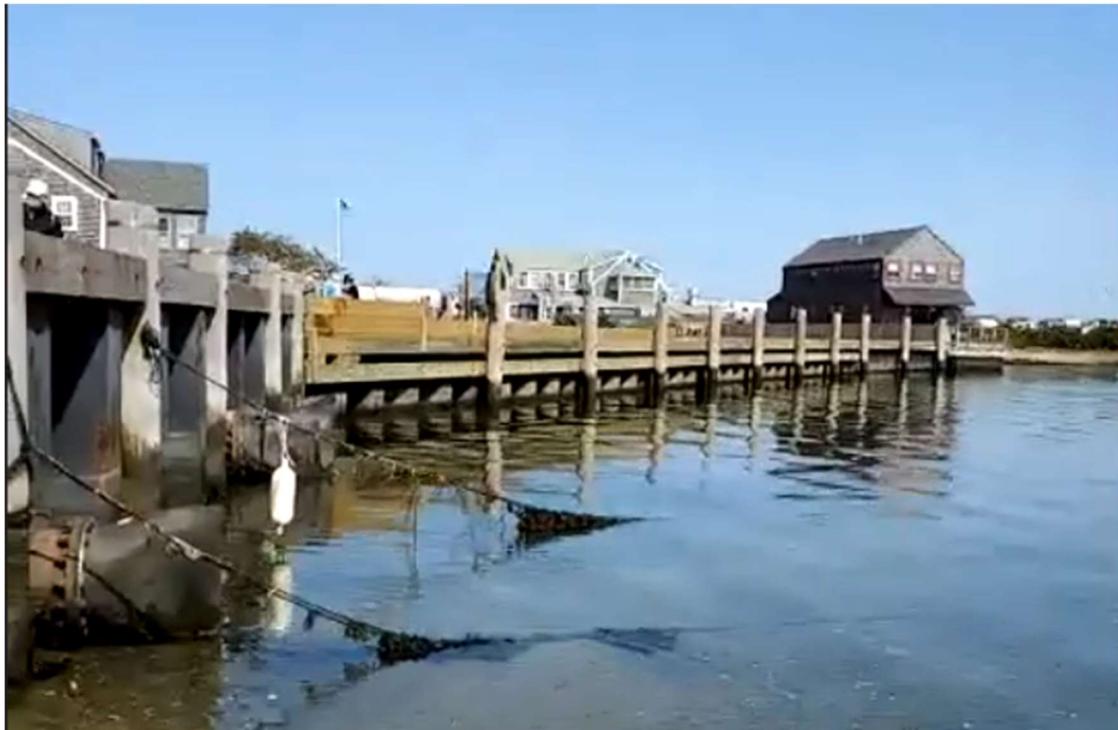
Figure 19: A wave attenuation wall near the intersection of Easy and Oak St. (V. Murphy, personal communications, Sept. 25, 2020)

and wave attenuation barriers in several locations downtown help reduce the severity, and impacts of flooding, but cannot prevent it entirely. These structures can be seen at Children’s Beach, Easy Street, and Francis Street Beach. The storm drainage system exits at the Easy Street bulkhead on Easy street through duckbill check-valves (V. Murphy, personal communication, Sept. 25, 2020). Unfortunately, while the check-valves were installed recently in 2017, they no longer function as designed and allow water to flow back through the storm drain system and pool on the street.

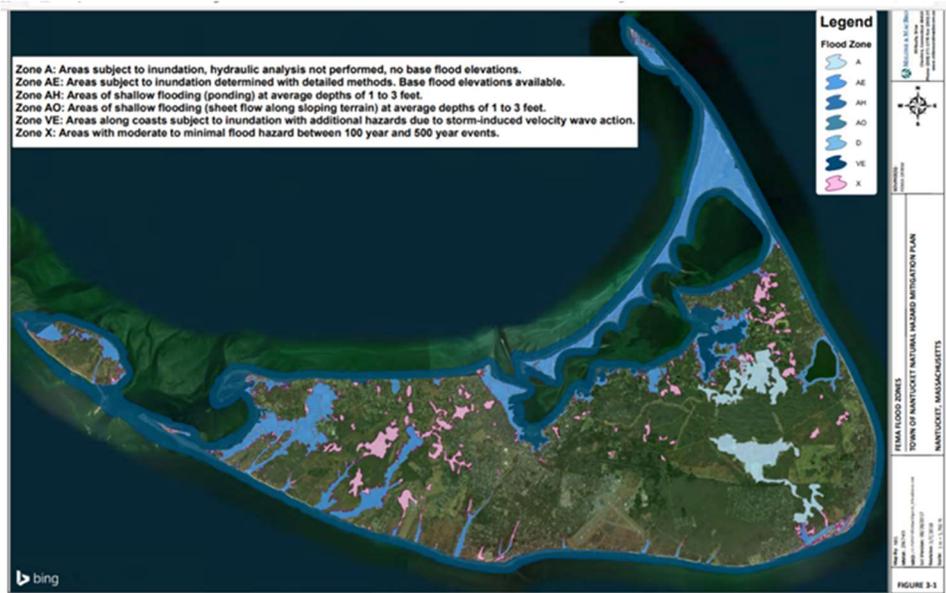
Figure 22: Map that shows predicted flooding areas for certain flood events, much of the downtown area according to this map is expected to flood (Hazard Mitigation Plan, 2019)

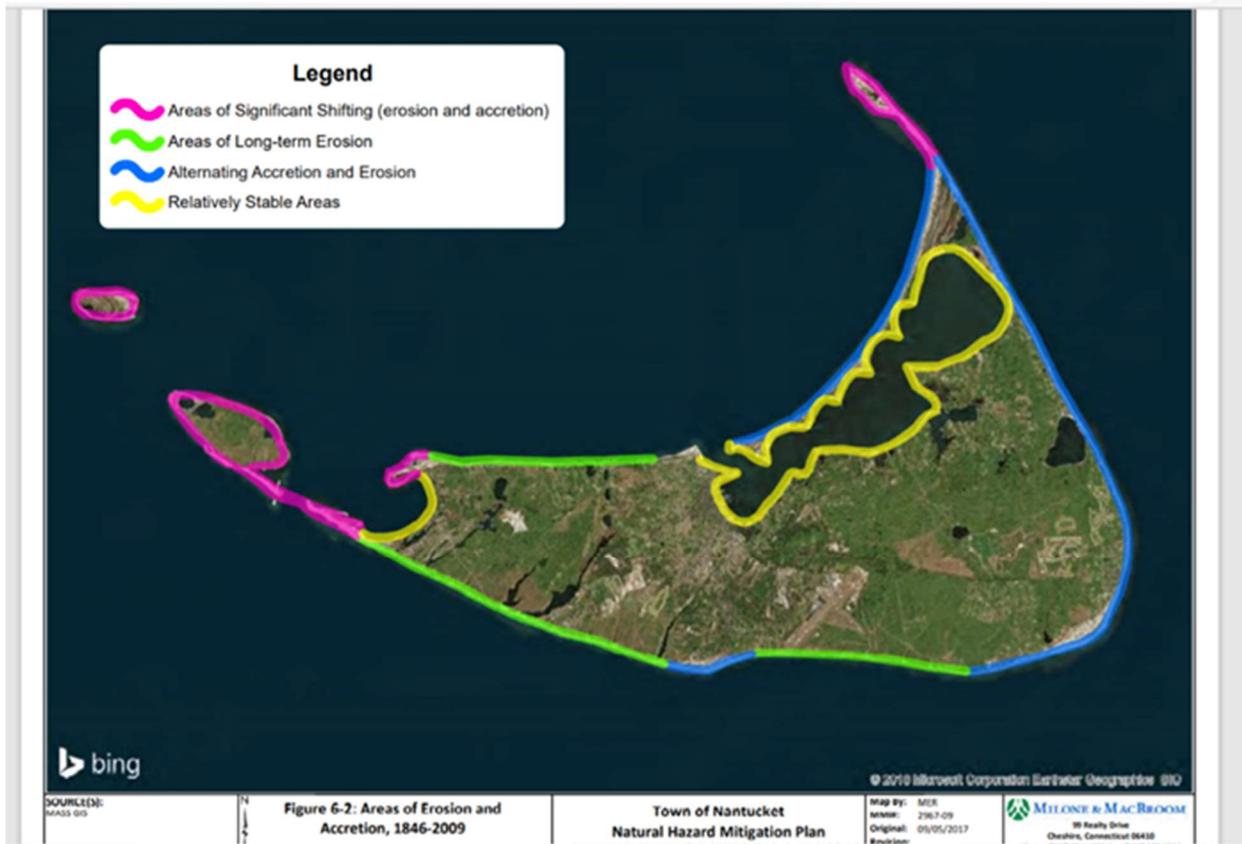
Figure 23: Areas of concern for erosion on the island (Hazard Mitigation Plan)

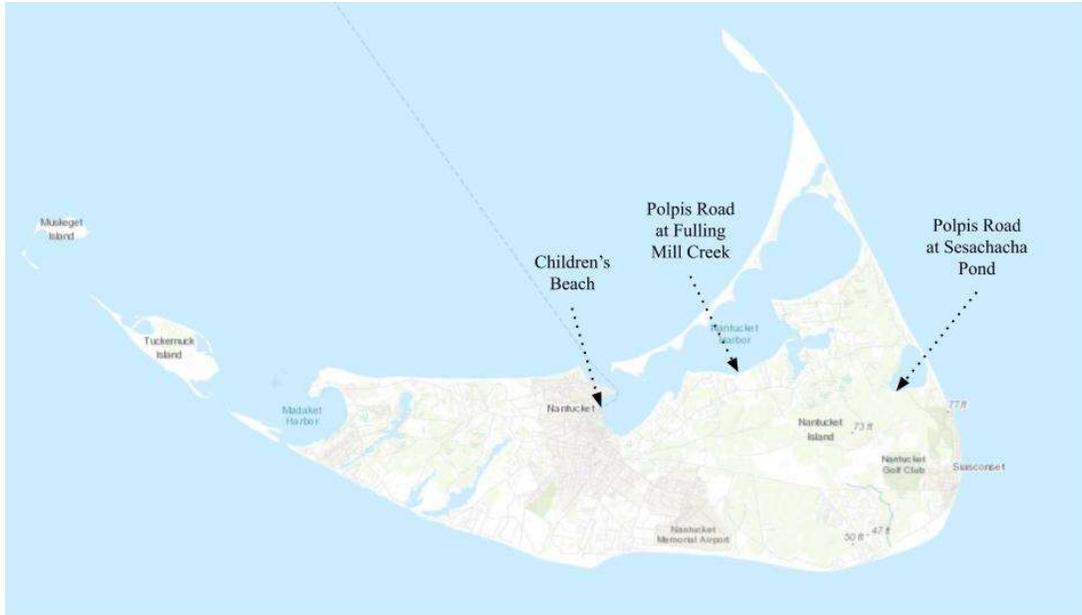
Figure 31: A map of Nantucket showing the case study locations. Base layer is from ArcMap.

We selected three locations as case studies to serve as examples for possible mitigation strategies on the island. We identified locations based off interviews with project sponsors Vincent Murphy and Peter Morrison as well as utilizing our database from objective one to identify areas with frequent flooding (Figure 31).

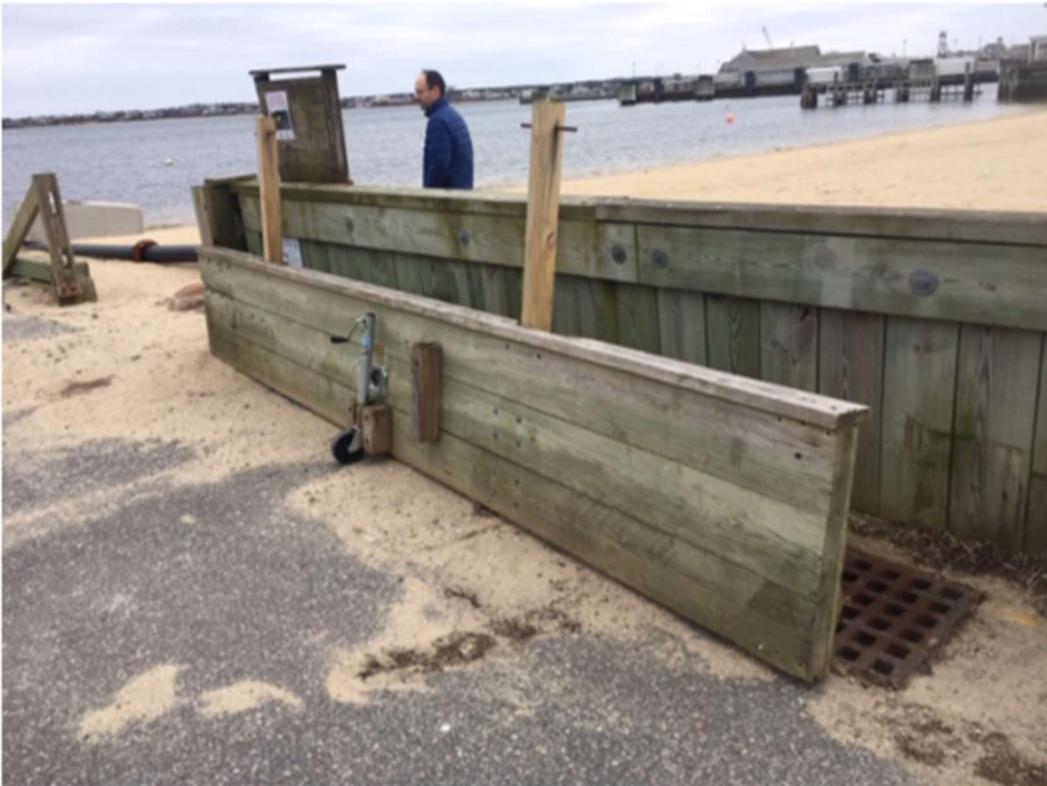
Figure 32: Children's Beach Tidal Gate (Fuss & O'Neil 2019)

The Children's Beach boat ramp is the only public boat ramp in the downtown area. The boat ramp is bordered by a retaining wall and the pier. Access to the ramp is controlled by a tidal gate managed by the DPW (Figure 32). During storms, the gate is shut by the DPW to block access to the ramp, break waves rising to shore and reduce the force of floodwaters in the area. When shut, the gate is reinforced through sandbagging and the placement of concrete jersey barriers which help the gate avoid damage from wave action. The jersey barriers also keep residents from opening the gates during a storm. The tidal gate is not meant to nor does it prevent inundation, but rather it serves as a wave attenuation device to reduce damages related to wave action. During most storm events on the island the gate is closed and reinforced however, "on several occasions private individuals have opened the gate during a storm's low tide to more rapidly drain the area and have not returned to close the gate before the next high tide cycle" (Hazard Mitigation Plan, 2019, p.30). When opened during a storm or even a king tide more

water is brought inland via the boat ramp and increased water force can damage homes and buildings.

1. Conclusion: The tidal gate is a critical piece of infrastructure that minimizes wave damage to the properties and infrastructure behind Children's Beach. Members of the public regularly open the gate to access the boat ramp but fail to close the gate afterwards leaving the area behind the beach vulnerable to flood damage. We recommend the town consider several options to address the problem:

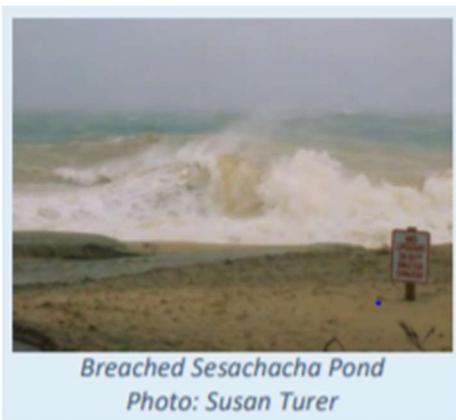
We selected the section of Polpis Road near Sesachacha pond for its unique location and run off issues. It is also a primary evacuation route for residents of Polpis and Wauwinet. When both the Polpis road by Sesachacha Pond and Milestone Road are blocked, residents who live in ‘Sconset are also isolated. Milestone road is outside of flood zones but can be rendered undrivable by snowdrifts. Under these circumstances, residents of Polpis, Wauwinet and ‘Sconset are all isolated. Sesachacha Pond is a large, shallow, brackish pond bordered by Polpis Road on the south and separated from the ocean by a barrier beach on the northwest. It is an “unconnected low-lying area” whose low elevation puts it at risk of breach from the Atlantic Ocean via Sesachacha barrier beach (Figure 33, MORIS - Coastal Inundation Uncertainty). Powerful nor’easters can breach the barrier beach and wind driven waves can flood the road and undermine its foundation (Figure 34) (Hazard Mitigation Plan, 2019, p.188).

Figure 34: From the HMP page 35: “Sesachacha Pond was breached by the Atlantic Ocean, causing inundation to extend inland and overtop Polpis Road, which was subsequently washed out.” (HMP page 135)

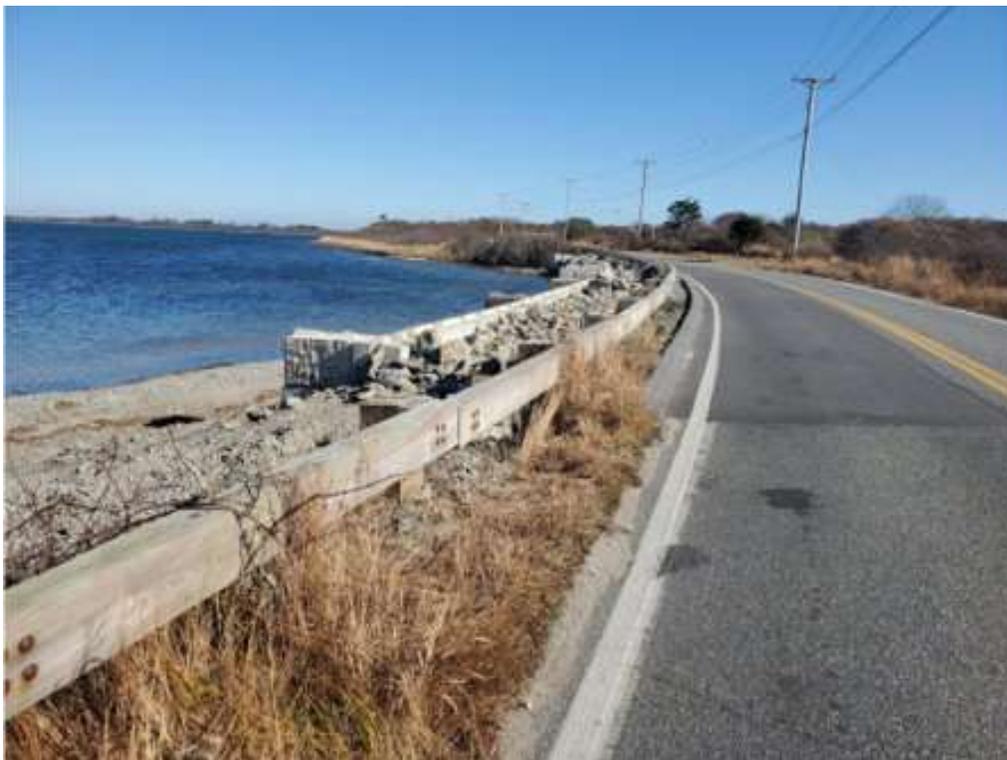
Figure 36: Image of Sesachacha Pond and Roadway. Image and description provided by Vincent Murphy.

Sesachacha Pond is bordered by wetlands. While wetlands are effective in retaining water, they do not drain rapidly. During high intensity or frequent storms, the wetlands become overburdened causing overflow onto the road. Water runoff collects on the surface of the road and any backflow from wetlands accumulates as well. Flooding may also compromise the structural support of the roadway. This section of road was recently repaired because the foundation beneath the it had eroded away causing collapse. The foundation for the road is made of non-porous materials allowing wind driven wave action to corrode its foundation (Rob McNeil Interview 12/3/2020) (Figure 35). In fact, wave action during a higher-than-normal pond elevation caused the original collapse. Polpis Road near Sesachacha Pond is well constructed

but, the interface between the pond and road is subject to impacts from the weather (Rob McNeil, Interview 12/3/2020) (Figure 36). Currently, cement blocks support the road's foundation while the DPW works to design, permit, and construct a more permanent solution (Rob McNeil Interview 12/3/2020). Until then, McNeil is working with the NRD to improve the existing concrete wall following the Wetlands Protection Act.

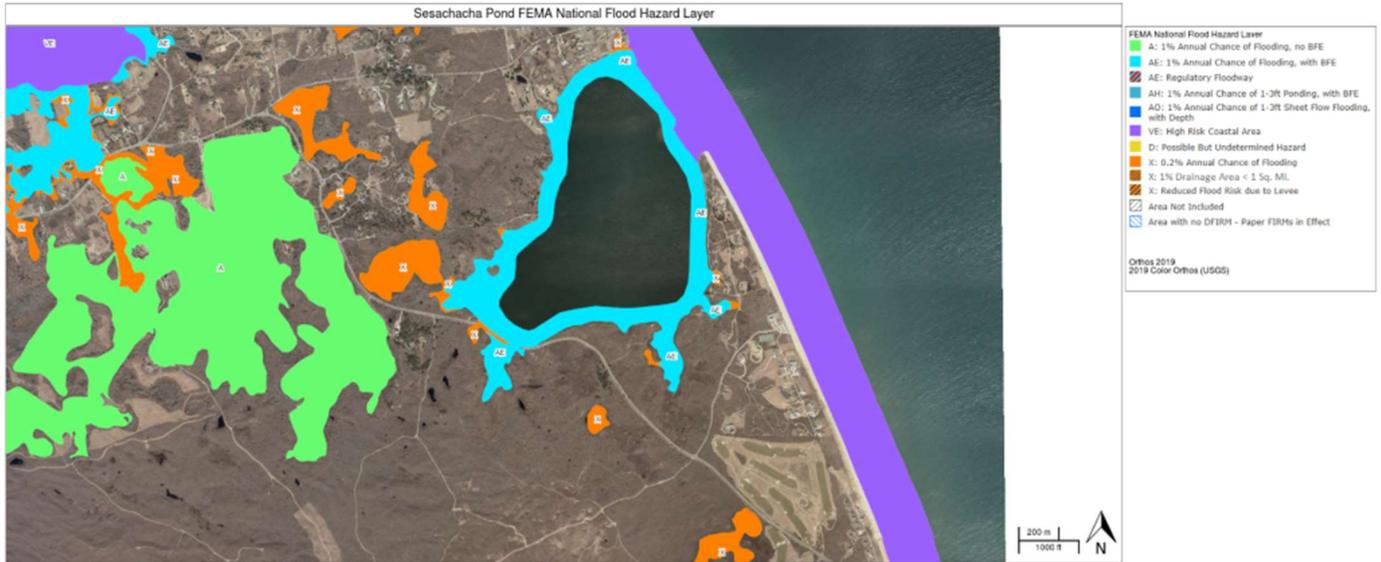
Figure 37: Polpis Road by Sesachacha Pond FEMA National Flood Hazard Layer (MORIS)

Polpis Road runs along the southwest edge of Sesachacha Pond through areas designated as 100- and 500-year flood zones (Figure 37). Despite the 100- and 500-year flood designations, flooding on Polpis road near Sesachacha pond is more frequent than numbers suggest. Especially if there has been significant rain, the pond is full and high winds are blowing from the east.

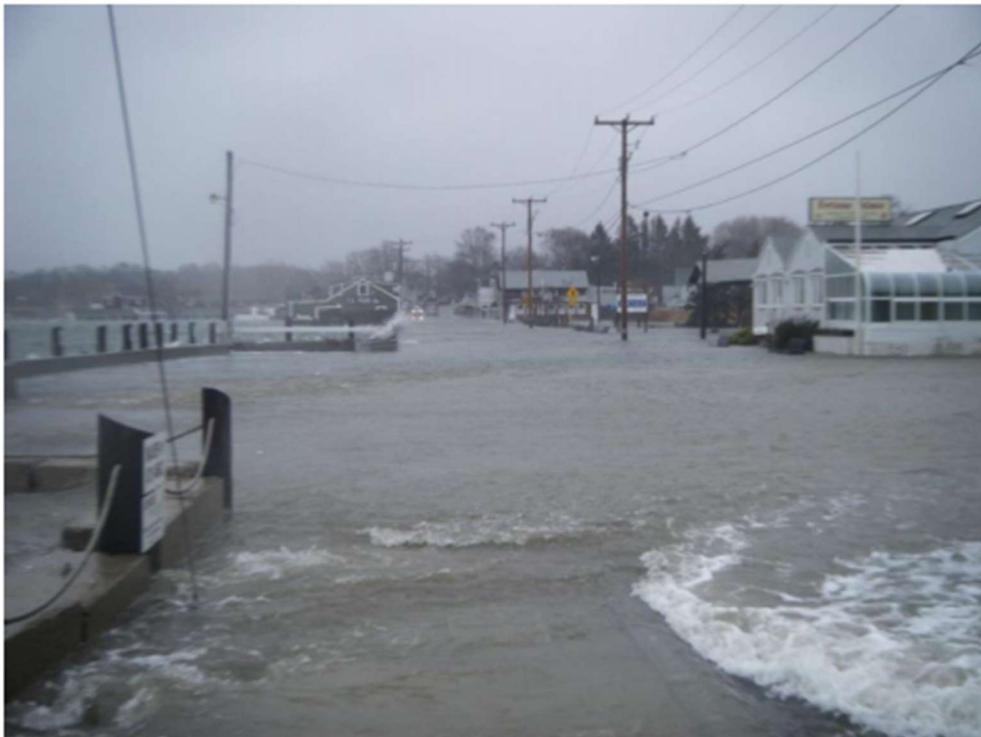
Figure 44: Image from the Essex HMP page 35 showing the "Essex Causeway" flooding. (Essex HMP, 2019, page 35)

To find mitigation strategies for the types of flooding Polpis Road experiences we researched Essex, MA and Falmouth, MA. The Causeway in Essex, MA faces a winter flooding issue. The Route 133 causeway floods regularly due to tidal inundation and impacts significant town infrastructure which “stretches for 0.8 miles and spans both salt marshes and the Essex River” (Essex HMP, 2019, pg. 72) (Figure 44). In 2012 Essex raised the road 8 inches to the maximum height allowed and installed tidal flaps on the causeway to further reduce flooding (Great Marsh Regional Coastal Adaptation Plan, 2017 seen in the Essex HMP, 2019, pg. 28). Their efforts reduced the severity and frequency of flooding at the causeway although it still floods multiple times per year (Essex HMP, 2019, pg. 28).

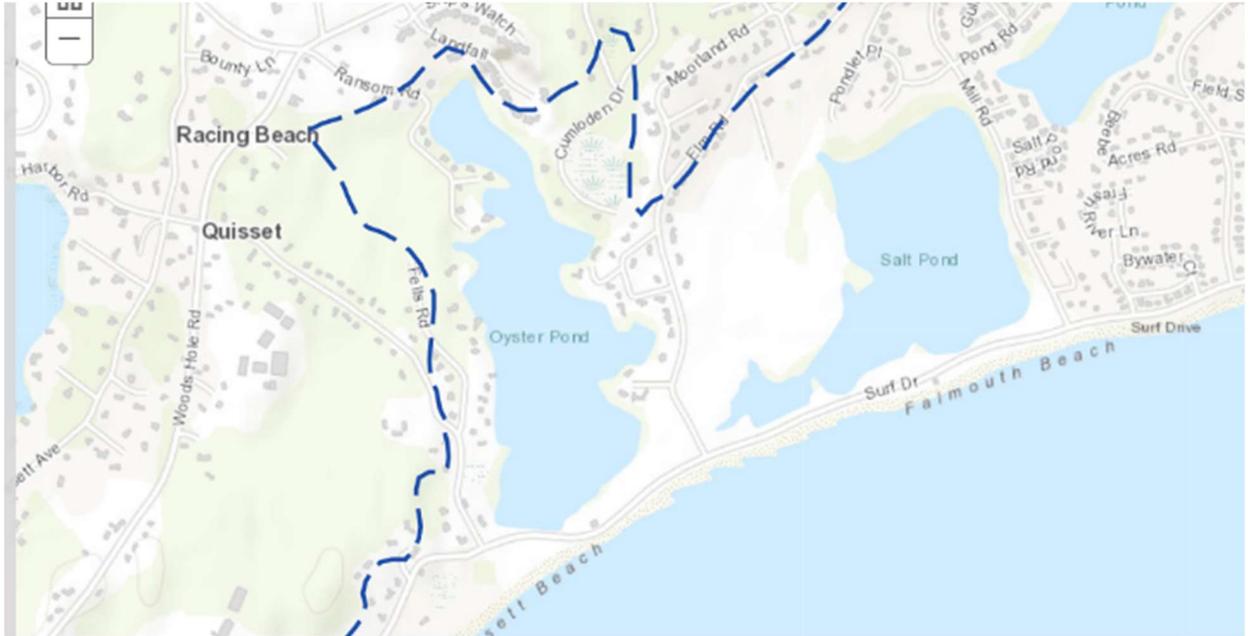
Figure 45: Coastal Resiliency Planning for the Surf Drive Area by the Woods Hole Group (whg.maps.arcgis.com)

Our research of Falmouth also resulted in possible mitigation strategies that are applicable to Polpis road by Sesachacha Pond. Falmouth Massachusetts is located on Cape Cod and faces a coastal flooding issue. Due to their proximity to Nantucket, they see similar sea-level rise issues. Nantucket and Falmouth share vulnerabilities to costal erosion, sea level rise and coastal flooding (Figure 45). Additionally, both Falmouth and Nantucket participate in the state-funding Municipal Vulnerability Preparedness (MVP) Program workshop opening them up to comparable grant opportunities. Surf Drive is one of the main roads in Falmouth that sits on an eroding beach that floods frequently (Figure 46). Oyster Pond and Salt Pond border the west side

of the road. Surf Drive is also a key emergency route that links Woods Hole to the rest of Falmouth. The similarities between Surf Drive by Oyster Pond and Salt Pond and Polpis Road by Sesachacha Pond make Falmouth a strong candidate for possible mitigation strategies for the Sesachacha Pond area.

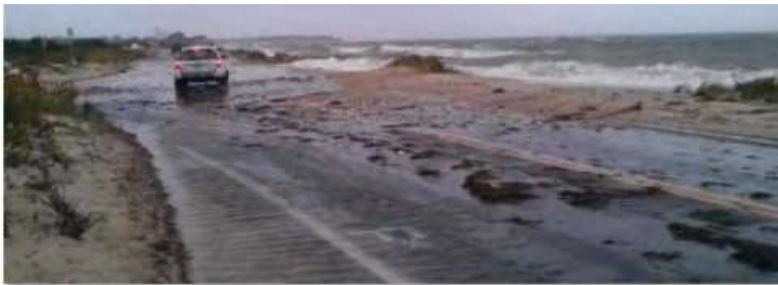
Figure 46: Falmouth's Multi Hazard Mitigation Plan Final Report March 2017 by the Woods Hole Group

Figure 3-3. Flooding on Surf Drive during Hurricane Sandy.

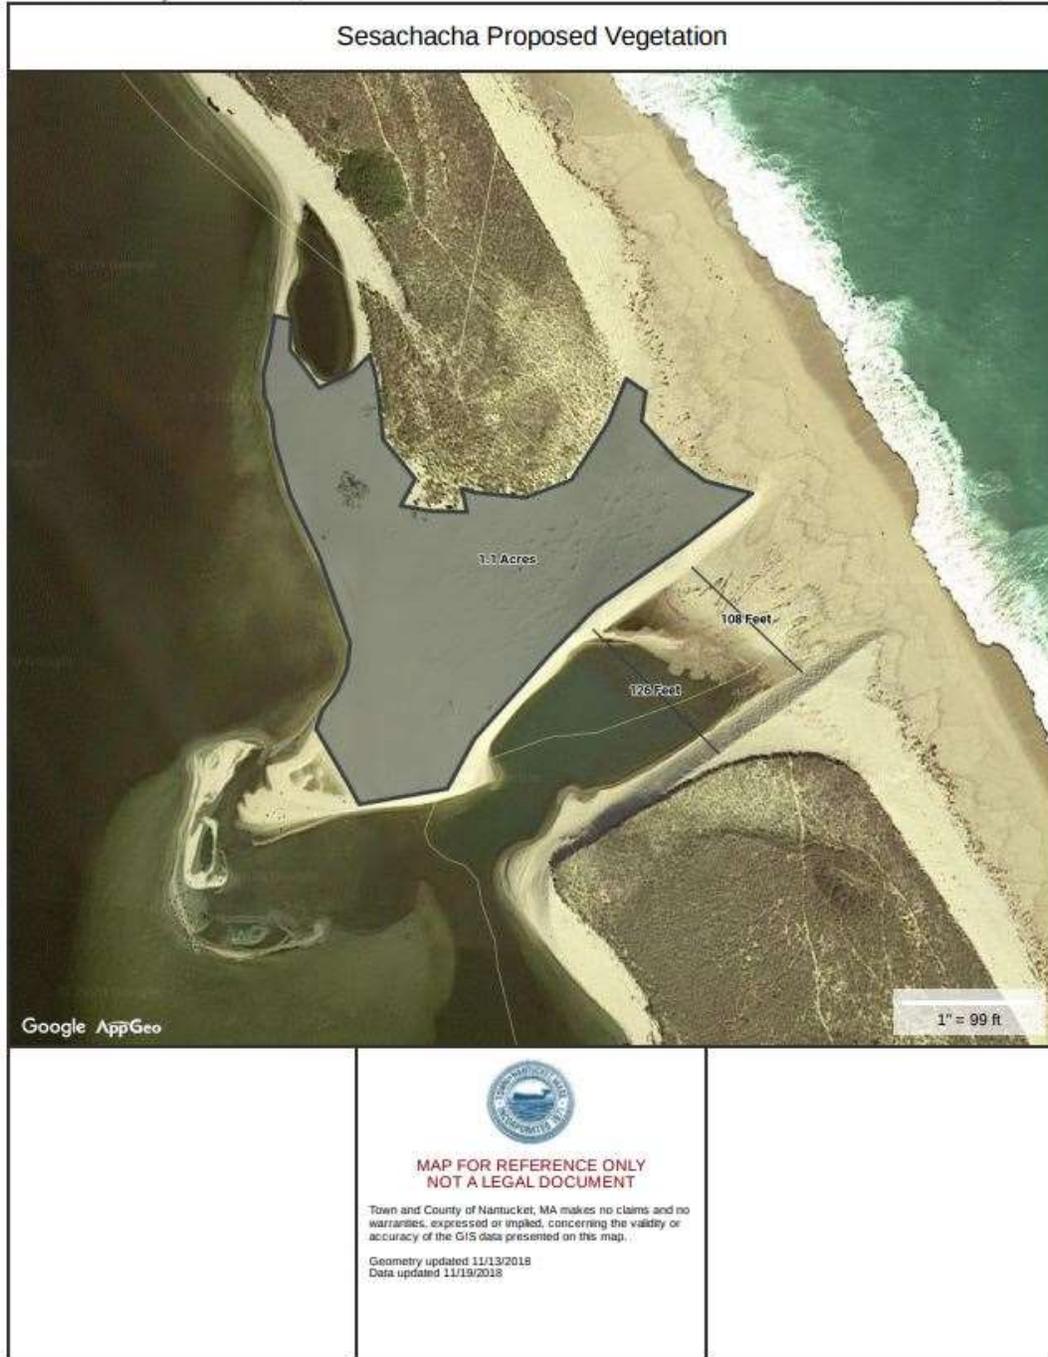
Figure 47: Area of proposed pipe and vegetation. Town and County of Nantucket, MapGeo. Edits measurements added by the flooding team using mapgeo.

Like Falmouth’s vegetation efforts, Nantucket could plant dense vegetation along the edge of Sesachacha between the pond and the ocean. Currently there are about 1.1 acres of sand, untouched by plant life (Figure 47). Additionally, there is a 108-to-126-foot gap where the bi-annual drainage efforts occur (Figure 47). To improve the efficiency of these efforts, a one-way pipe with a check valve flowing from Sesachacha Pond into the ocean could be installed in this area and backfilled as needed. Backfilling the 108-126-foot gap will also fortify the barrier beach by increasing the surface area both for wave attenuation and dense plant vegetation.

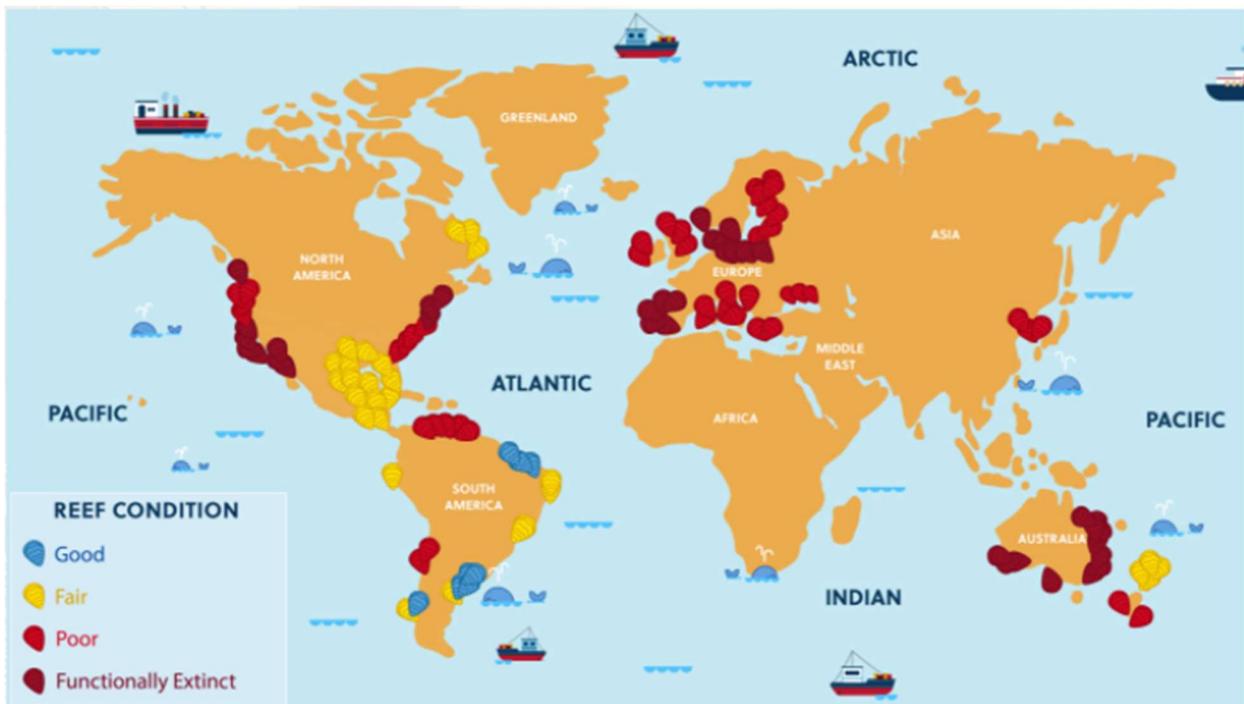
Figure 58: A map showing where oyster reefs are currently or where they used to be and their condition

sustainable populations across the world (Figure 58), Nantucket is one of the few places with a sustainable hatchery. The Shellfish Propagation Program aims to “Develop and implement a shellfish management plan ... to protect and enhance the island’s shellfish resources, employing either community-based management or co-management” (Herr 2012). The NRD collects waste shells from surrounding restaurants and uses them to create new sections of reef on which juvenile shellfish can grow. The shellfish program is one of the most demanding activities for the NRD. They must continuously monitor the shellfish populations and actively develop the fishery.
